# QHSSE Observation Report

Sample output · Unsafe act · Working at height

OBS-2026-0418

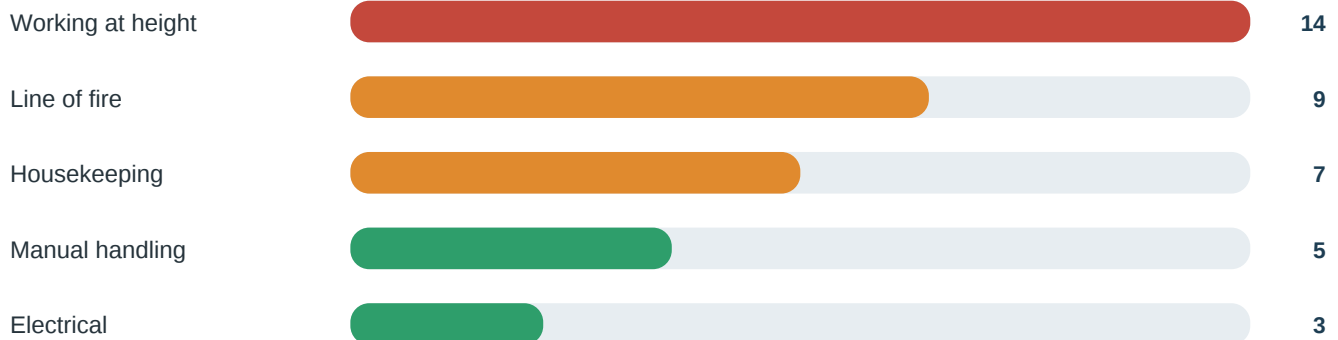
## DETECTED TREND — LAST 90 DAYS

The platform reviews every observation across the organisation and flags recurring patterns. This observation is one of 14 working-at-height reports raised at the same site in 90 days.
